**Flood Control Project Maintenance
Levee Inspections**
LMA District Cover Sheet
Spring 2018 Levee Inspection Results

Reclamation District No. 2091 Chase

Spring 2018 Levee Inspection Results

Waterway			Bank	Unit Miles
Unit No. 01 San Joaquin River			Right	7.46
	Spring (March - May)	Summer (June - August)	(September - November) Fall	Winter (December - February)
Unit Maintenance Rating (Fall Only)				
Date of Inspection	5/1/2018 - 5/1/2018			
DWR Inspector	Richard Willoughby			
Accompanied By

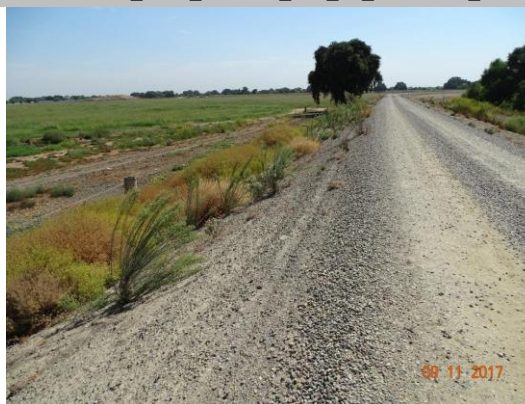
Photo 1 of 1 : SP_2018_RD2091_318_36_20180307_00031.jpg

LM Start	6.23	Rating **	M	Issue No.	36
LM End	6.27	Issue Type +	Ma	Location *	LS
Category	Earthen Levee			GPS Latitude/Longitude	
				Start	End
Item	Vegetation			37.485724 °	37.485234 °
				-121.058443 °	-121.058032 °
DWR ID	DWR_RD2091_01_f_2017_36				
Comment Code					
V2 : Remove the wild growth other than native grasses from the levee slopes.					
Inspector Comment

Looking southeast at landside slope.

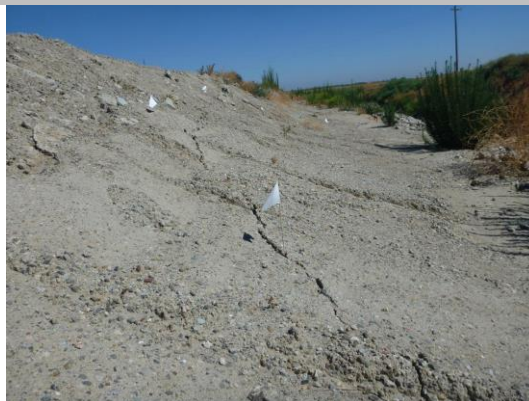
Photo 2 of 3 : LEVAL_SP_2018_473_2330.jpg

LM Start	7.45	Rating **	A/W	Issue No.	23
LM End	7.45	Issue Type +	Ma	Location *	
Category	Supplemental			GPS Latitude/Longitude	
				Start	End
Item	2017 Storm Damage			37.479000 °	37.479000 °
				-121.044000 °	-121.040000 °
DWR ID	DWR_RD2091_01 f _ 2017_23

Levee Evaluation Comments
Description: Sloughing at Mile 7.59 of the San Joaquin River
Site ID No: 473
Site Designation: LMA-300
Repair Type: Erosion
Rating: Area of Concern
Field Date: 7/20/2017
Notes: Concrete rubble was installed here during the storms after noticing cracks and sloughing. It has rebar sticking out and needs to be replaced with clean rip rap. Responsibility is grey here because TID maintains channel and placed concrete during storm.
